SUMMARY REPORT

1348 E Los Arboles Dr,, Tempe, Arizona 85284

3/19/2015 8:00 am to 12:30 pm

PRELIMINARY SUMMARY REPORT

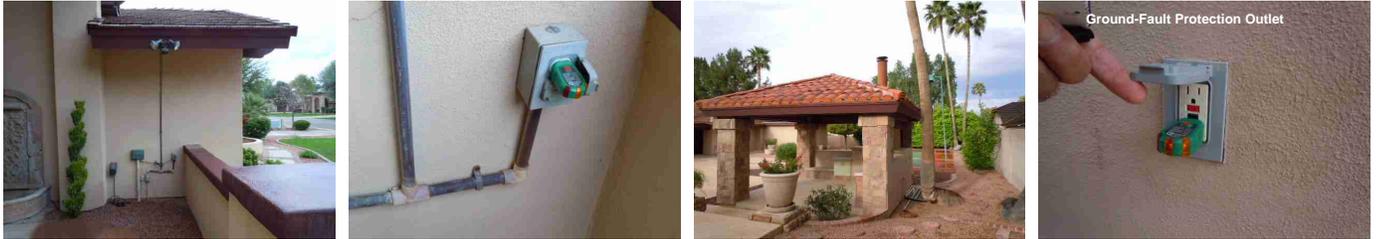
2.2 - ✓ All Exterior Outlets should include protection by a Ground-Fault-Protection Device, this is an affordable Safety feature that has been required since the mid-70's on all Exterior Outlets, it saves life's! Note: there is no State grandfather clause when it comes to Safety!!

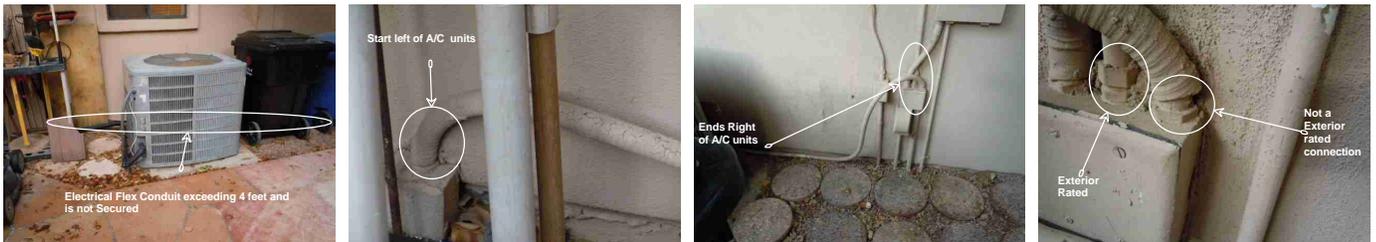
2.3 - ✓ Electrical Flex Conduit exceeding 4 feet and is not Secured. We recommend the further review, advice and services of an electrician

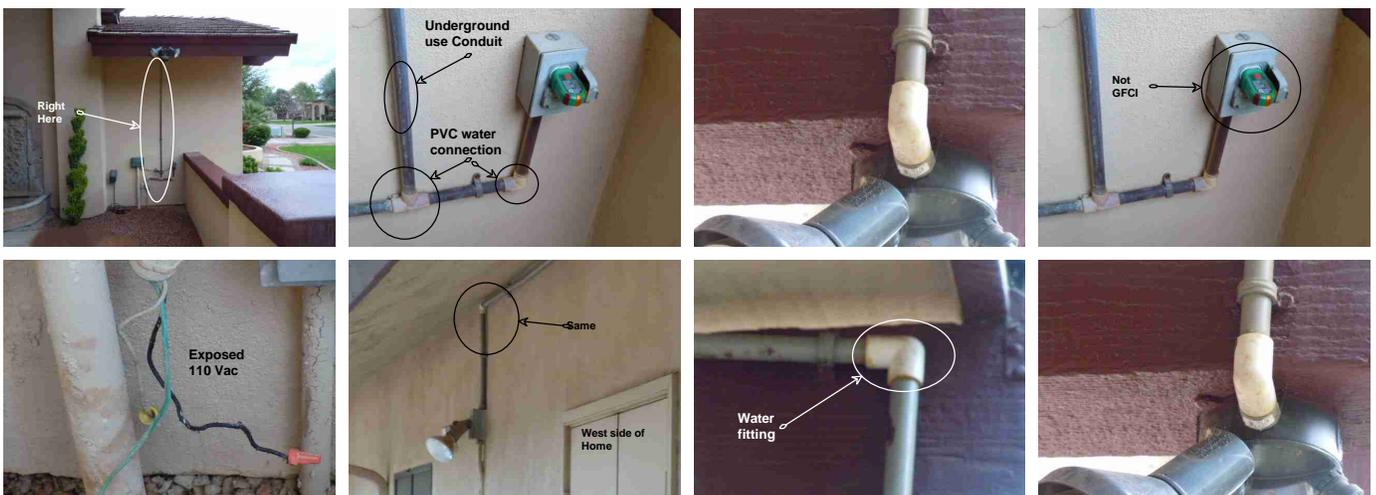
2.4 - ✓ Improperly installed Electrical Conduit on the South East side of the Home, there are Water fittings used in conjunction with PVC Conduit. Recommend further evaluation and advice from an Electrical contractor

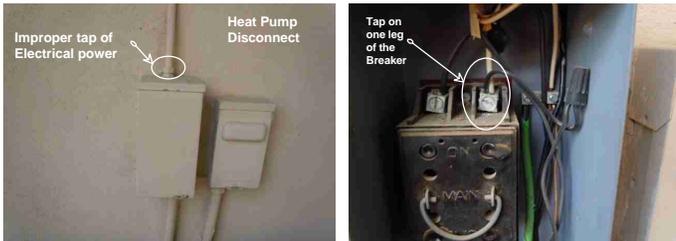
Improper tap of Electrical power - *Continued*

2.5 - ✓ There is Improperly tapped Electrical power from a the Heat Pump Disconnect. Recommend further evaluation and advice from an Electrical contractor

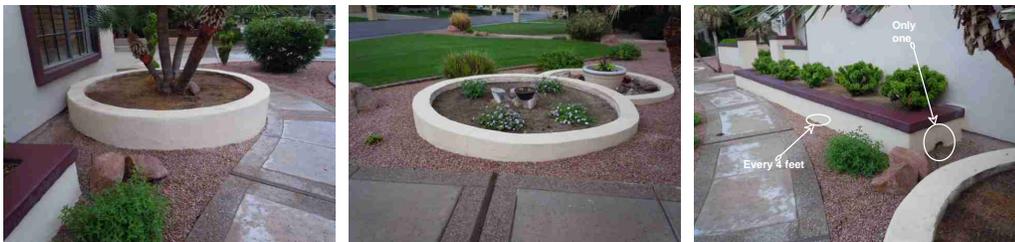
2.6 - q Concrete Masonry Planter requires drain holes to prevent moisture damage or intrusion. We recommend further review, advice and services of a Handyman Service.

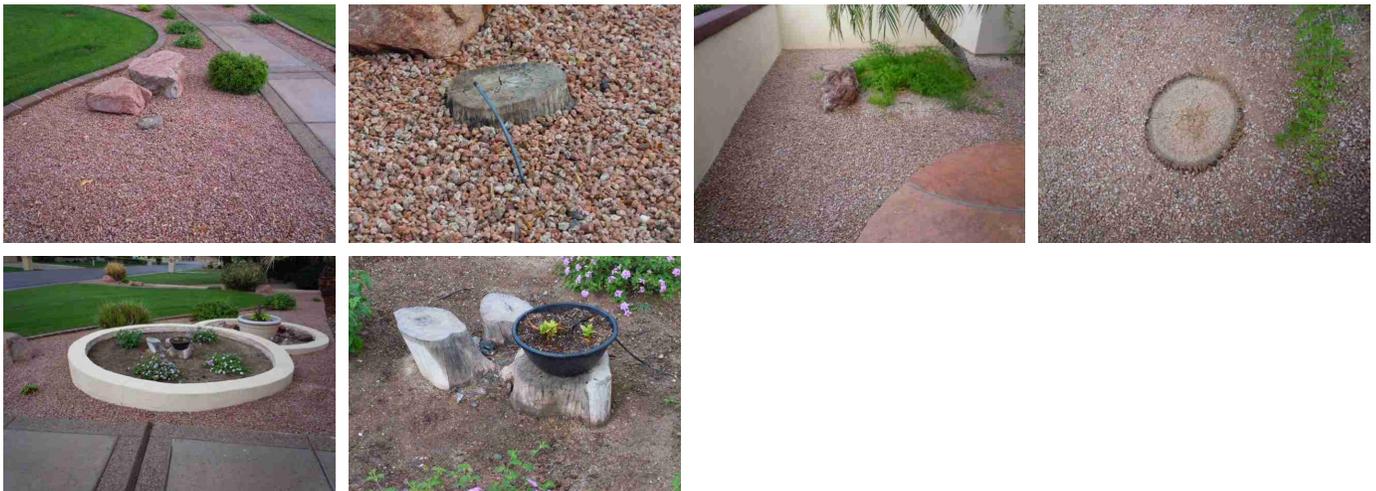
2.7 - q There are tree stumps located in the yard that you may wish to have Removed. Recommend advice and cost from a Licensed Arborist.

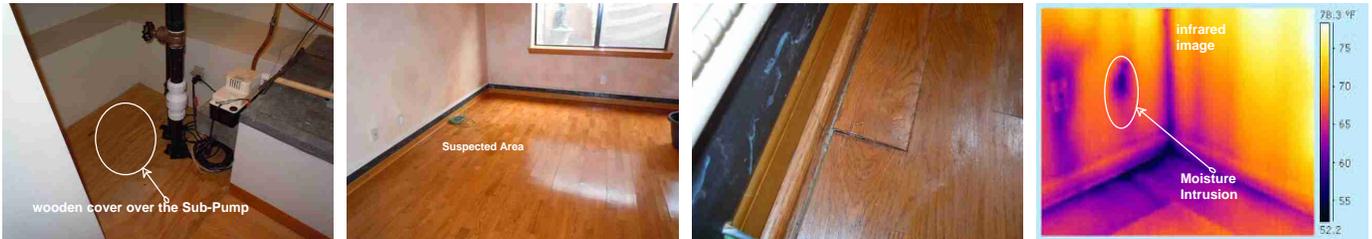
- 9.1 - □ There is a musky order coming from the Basement, wooden cover over the Sub-Pump and moisture damage was noted in the in the Basement flooring.
Recommend Evaluation by a Licensed Mold remediation contractor, repairs as necessary and Post Remediation air sampling before re assembly.

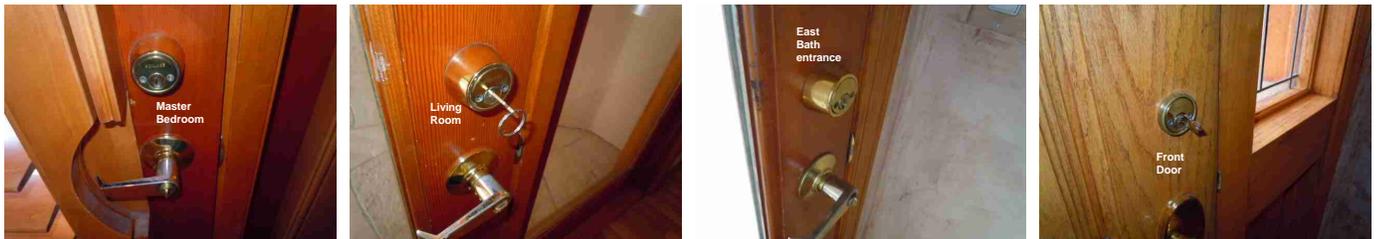
- 9.3 - √ The double or keyed deadbolt could prevent or impede an emergency exit, and should be replaced with a safer latch type.

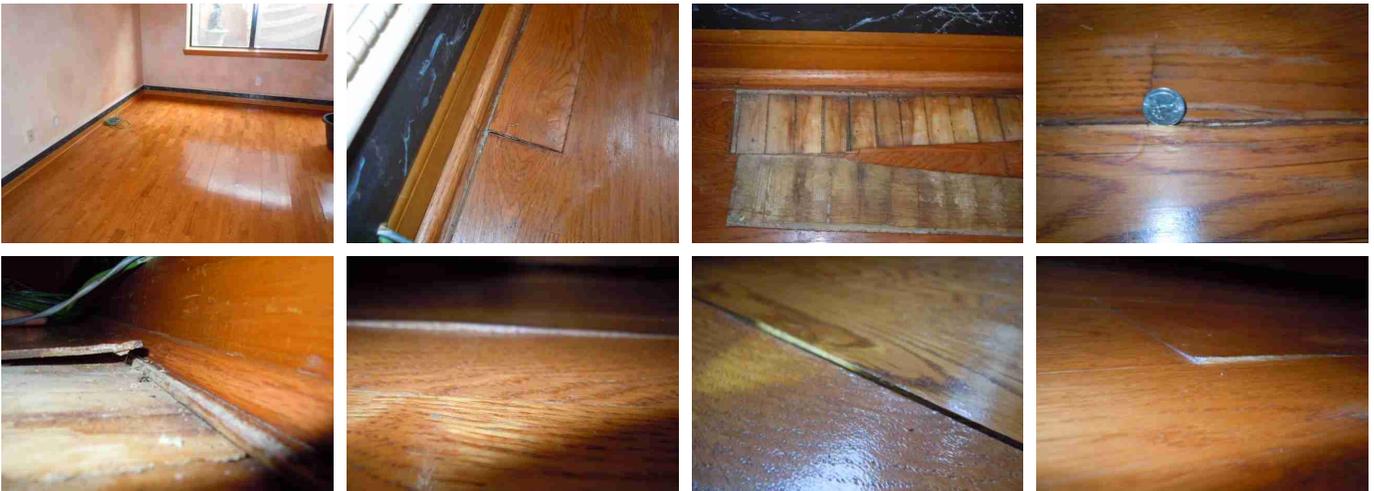
9.5 - □ The common areas of the Basement flooring is Engineered wood. There are areas that show signs of Moisture damage. Is the Moisture damage from a failing Moisture barrier or leakage from Exterior Walls?

Recommend removing Wood flooring from the Basement and installing Tile and if Exterior egress is leaking repairing that first.

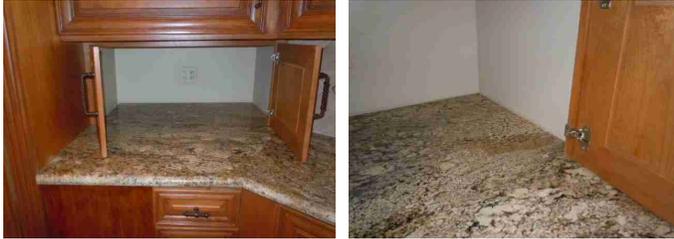
12.2 - ✓ There is no backslash installed within the Bread Cabinet, Backslash is to forestall moisture intrusion into the walls. We recommend the further review, advice and services of a Handyman Service.

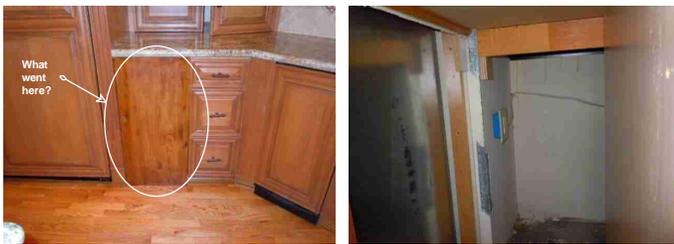
12.3 - □ What went here - Ice maker? Electrical power and a water line are behind the cover

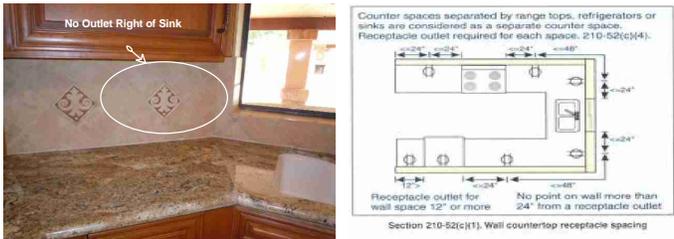
12.4 - ✓ There are not as many outlets as would be required by current standards, and you may wish to consult an electrician with a view to adding more.

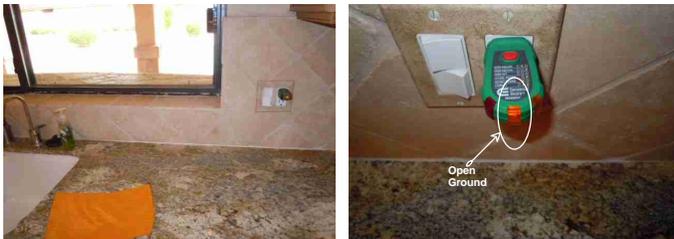
12.5 - ✓ All of the countertop outlets should include ground fault protection (GFCI), which is mandated by current standards and is an important safety feature. We recommend the further review, advice and services of a Handyman Service.

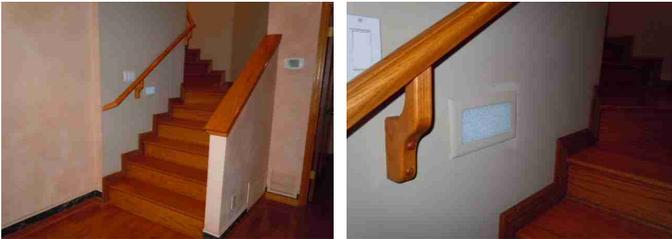
15.1 - √ A wall light did not respond, and should be serviced.

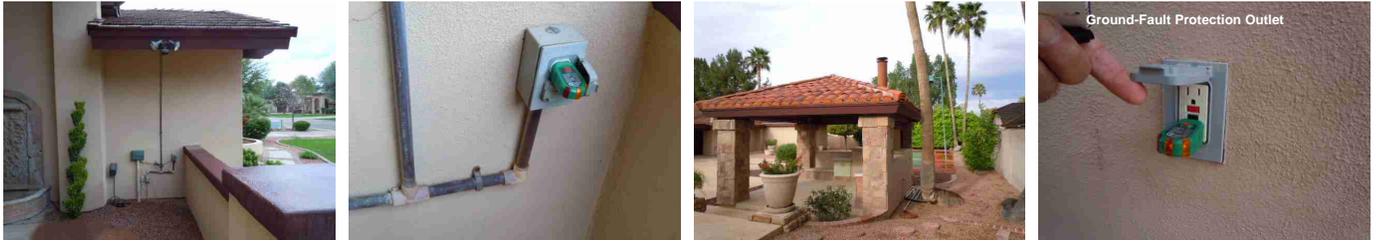
not ground-fault protection - *Continued*

v 2.19 - All Exterior Outlets should include protection by a Ground-Fault-Protection Device, this is an affordable Safety feature that has been required since the mid-70's on all Exterior Outlets, it saves life's! Note: there is no State grandfather clause when it comes to Safety!!

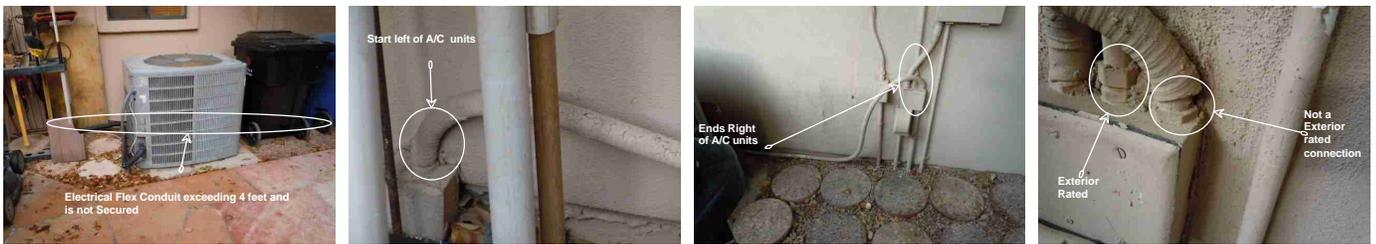
- 2.20 - Electrical Flex Conduit exceeding 4 feet and is not Secured. We recommend the further review, advice and services of an electrician

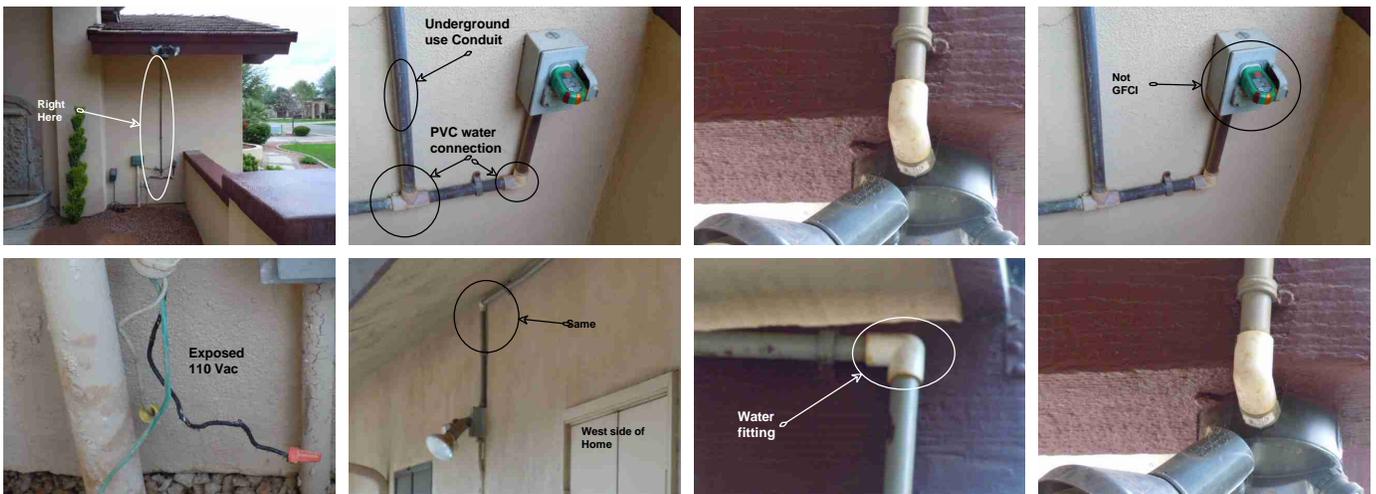
- 2.21 - Improperly installed Electrical Conduit on the South East side of the Home, there are Water fittings used in conjunction with PVC Conduit. Recommend further evaluation and advice from an Electrical contractor

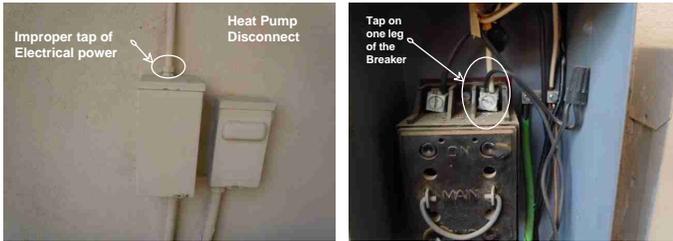
- 2.22 - There is Improperly tapped Electrical power from a the Heat Pump Disconnect. Recommend further evaluation and advice from an Electrical contractor

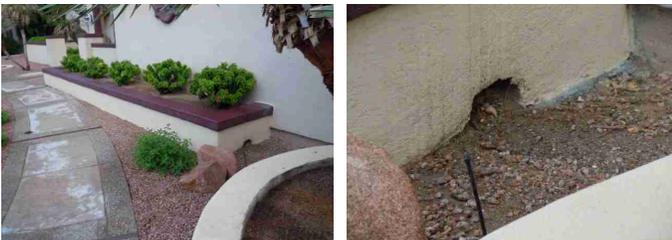
- 2.27 - Masonry Planter walls which have dirt piled against them should be considered retaining walls even though they may be very short vertically. There is drain holes and a Moisture barrier in place and appears to be in acceptable condition.

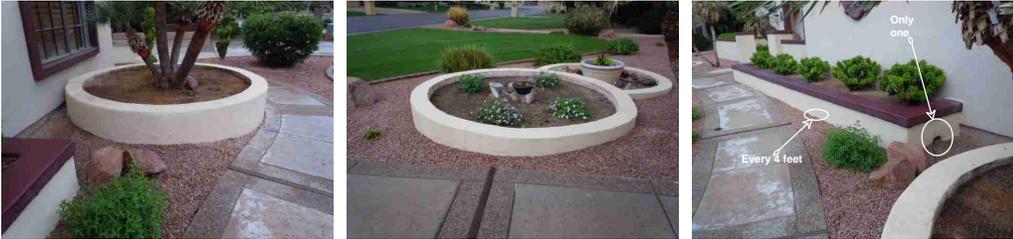
- q 2.28 - Concrete Masonry Planter requires drain holes to prevent moisture damage or intrusion. We recommend further review, advice and services of a Handyman Service.

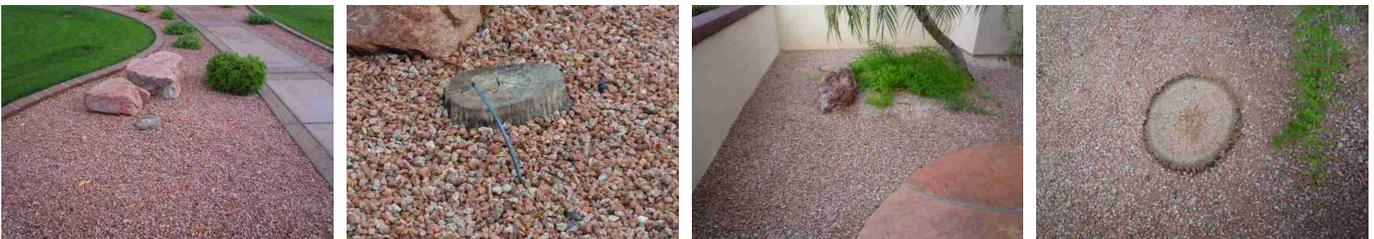
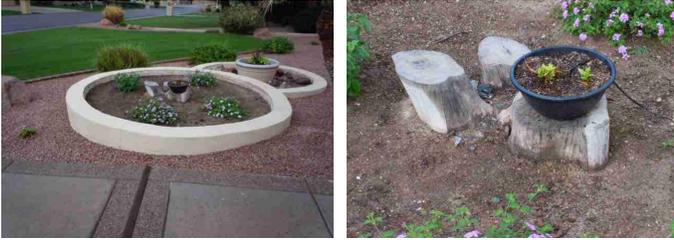
Tree Stumps - Continued

- q 2.32 - There are tree stumps located in the yard that you may wish to have Removed. Recommend advice and cost from a Licensed Arborist.

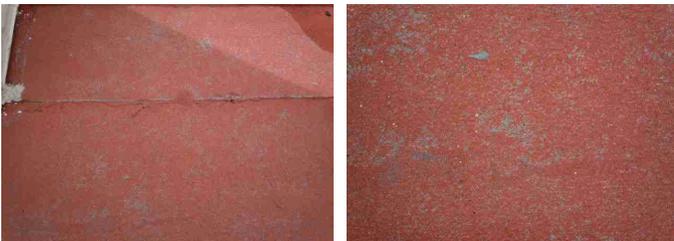
- 3.5 - The roofing material is losing granules but would not need to be replaced at this time.

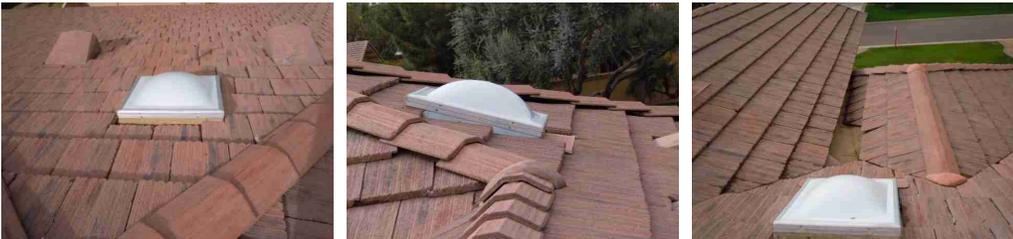
- 3.7 - The roof includes one or more skylights, which are notoriously problematic and a common point of leaks. There are different methods of installing them and, although opinions will vary, some methods are better than others. Therefore, it will be important to keep the area around them clean and to monitor them for evidence of leaks.

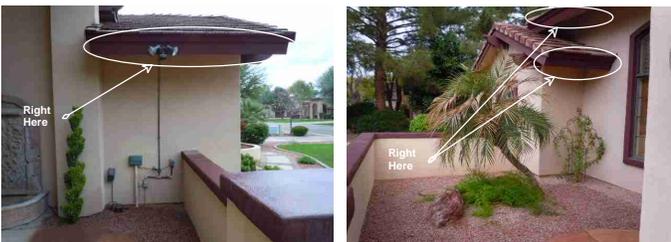
- 3.9 - Gutters recommended on the East & West facing side of the front patio, Recommended to deflect rain run-off from pounding within the front patio area for the general welfare of the residence and its foundation, inasmuch as moisture is a perennial problem.

We recommend further review, advice and services of a Rain Gutter Contractor.

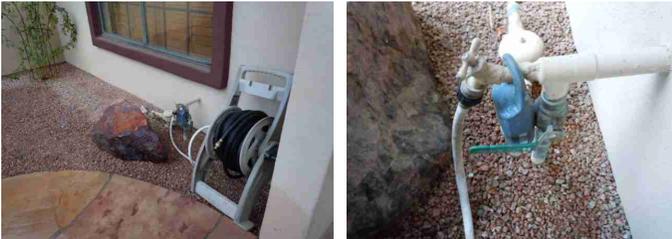
- Water shut-off valve is located in front

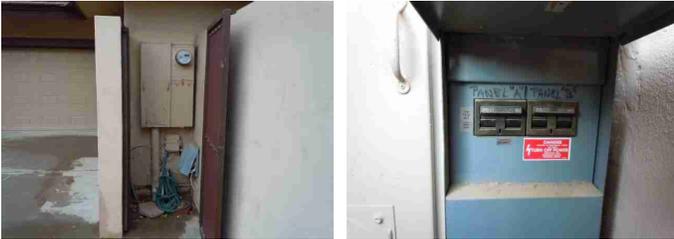
- There two 200 amp main Breakers that are located on the garage side yard

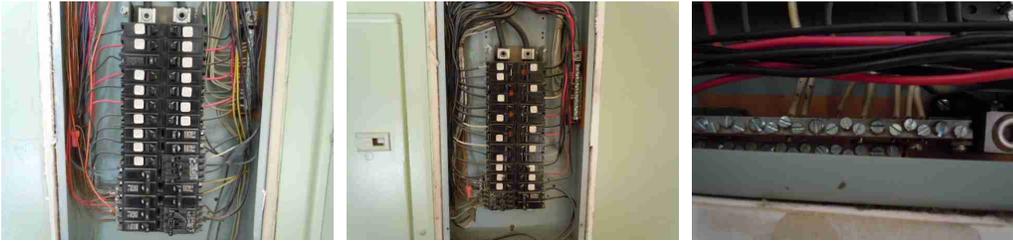
There are no visible deficiencies with the wiring in the sub panel - *Continued*

- 5.14 - There are no visible deficiencies with the wiring in the sub panel.

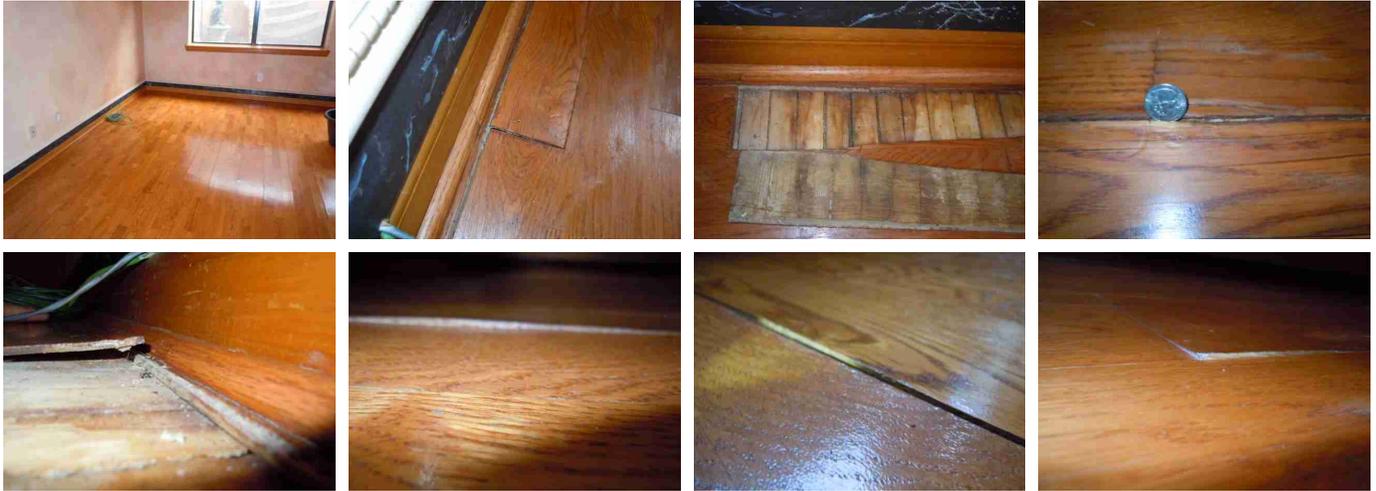
- q 9.14 - The common areas of the Basement flooring is Engineered wood. There are areas that show signs of Moisture damage. Is the Moisture damage from a failing Moisture barrier or leakage from Exterior Walls?
Recommend removing Wood flooring from the Basement and installing Tile and if Exterior egress is leaking repairing that first.

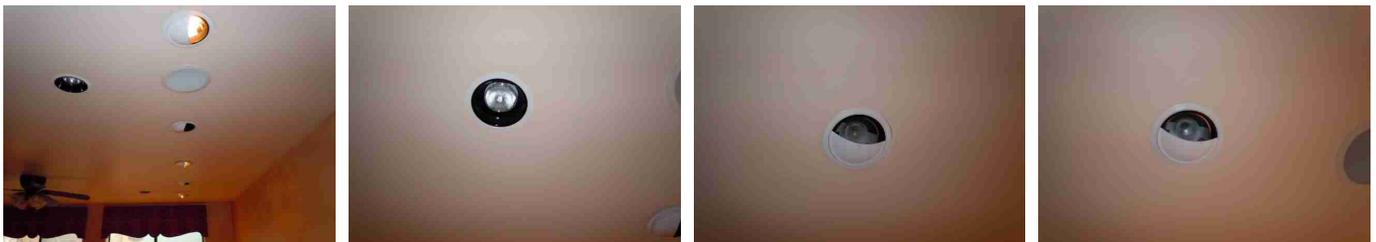
- 9.18 - A ceiling light does not respond, and should be serviced (Bulb?)

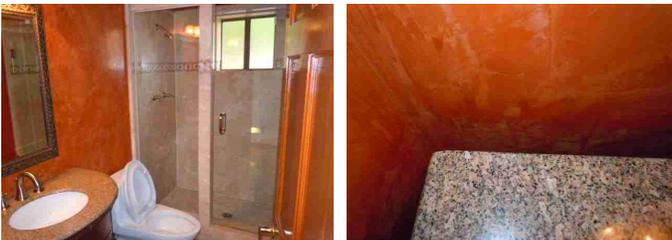
v 11.36 - Bask splash is missing, which should be sealed to forestall moisture intrusion between the cabinet and the wall.

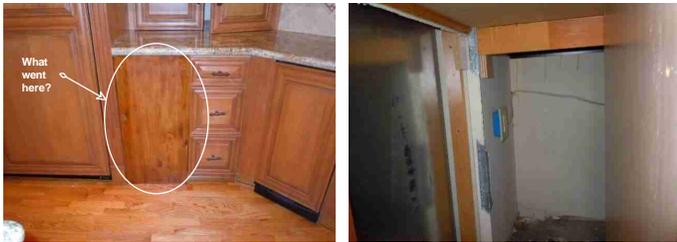
q 12.7 - What went here - Ice maker? Electrical power and a water line are behind the cover

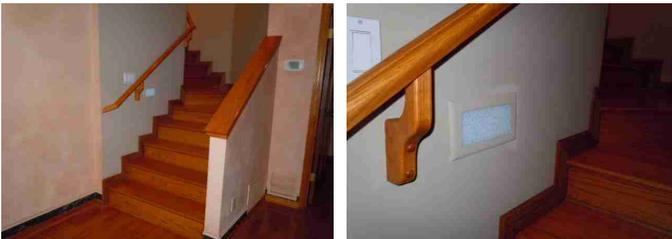
- v 15.4 - A wall light did not respond, and should be serviced.
